# Property Inspection Report

EXPERT HOME  
INSPECTIONS LLC

**Date of Inspection: 3/25/2025**  
**Year Built: 1978 Size: 2 story**  
**Weather: Full Sun**

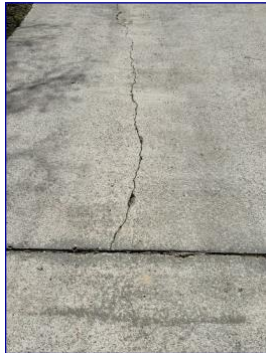
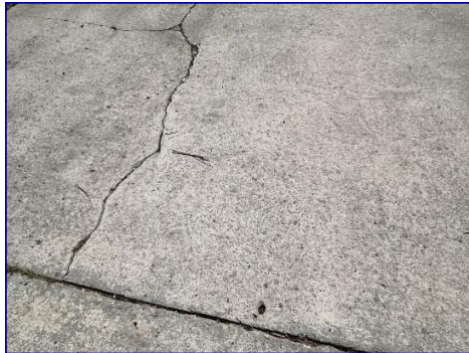
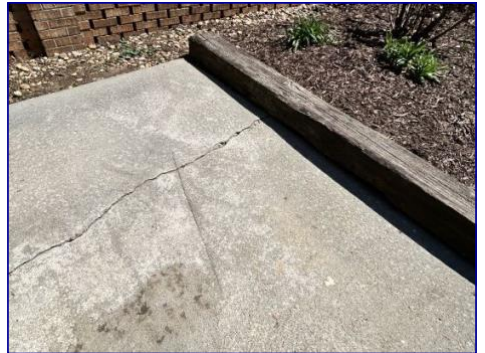
- Settling cracks

- The driveway is cracked. Recommend sealing the cracks to help prevent additional damage. Consult a professional contractor as needed.

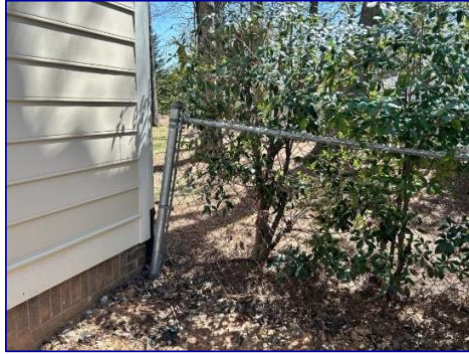
- The fence is excluded from the home inspection. All comments are made for courtesy purposes only. Damage to the fence on the right side of the home.

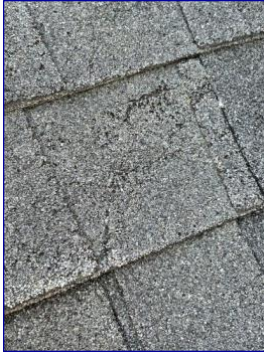
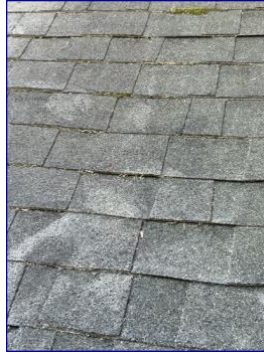
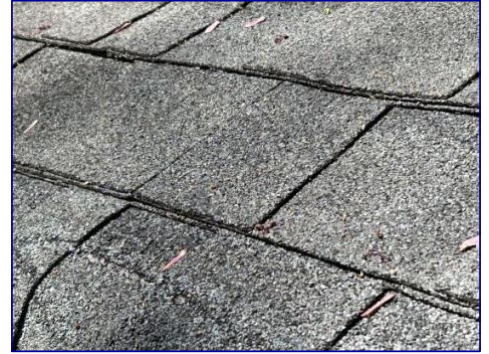
| Roof | | |
|---|---|---|
| Page 5 Item: 5 | Condition of Roof Covering | • A number of roof shingles are missing granules and possible tree limb damage. Recommend a licensed roofer evaluate and repair/replace shingles as needed. |

- Condition:
- Cracking
  - Granules missing
  - Moss buildup
  - Recommend roofer evaluate
- Observations:
- A number of roof shingles are missing granules and possible tree limb damage. Recommend a licensed roofer evaluate and repair/replace shingles as needed.
  - A number of roof shingles are missing granules and possible tree limb damage. Recommend a licensed roofer evaluate and repair/replace shingles as needed.

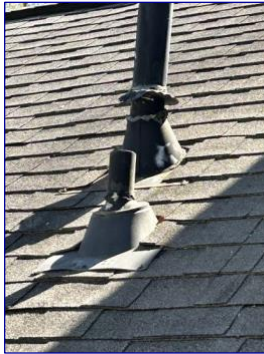
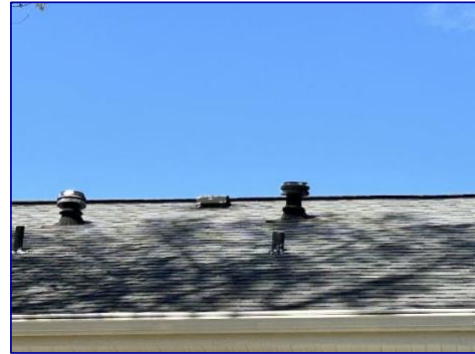
- The rubber boot on the plumbing vent is old and cracked, which can allow water to penetrate and cause damage to the roof coverings. Recommend a licensed roofer repair.

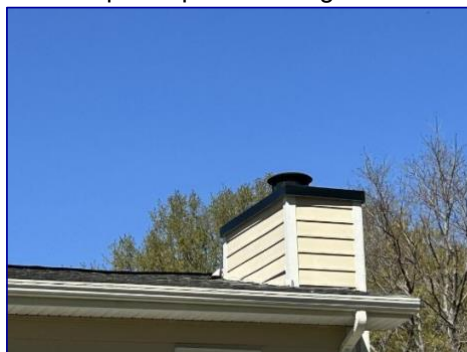
- The siding had some damage on the back of the chimney at the roof line, recommend a licensed contractor repair/replace damaged sections.

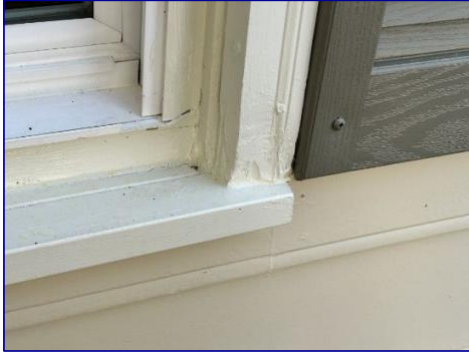
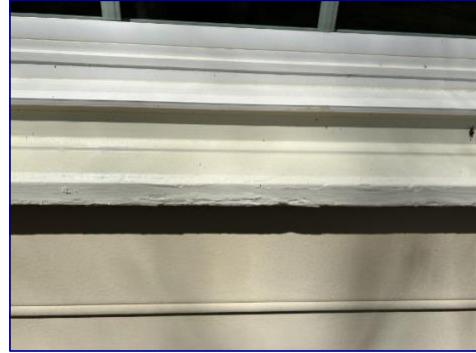
- There is damaged brick mold and sill nosing on some windows. This is a cosmetic defect only.

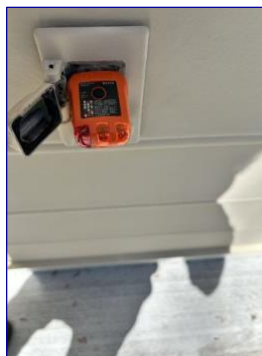
- Exterior receptacles: Yes
- Recommend **GFCI** receptacles

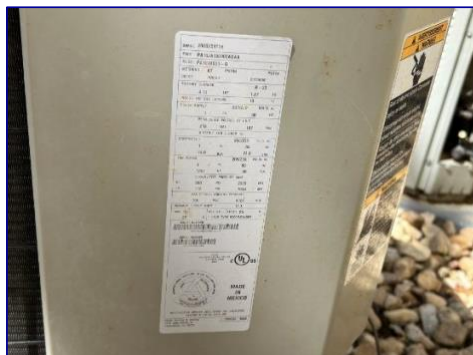
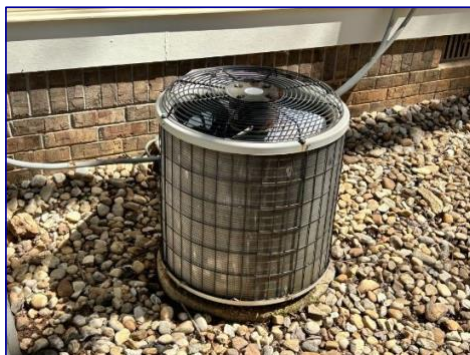
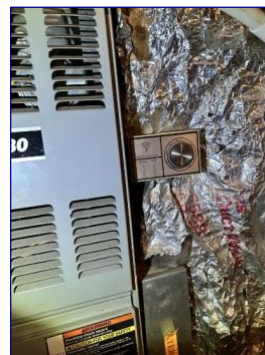
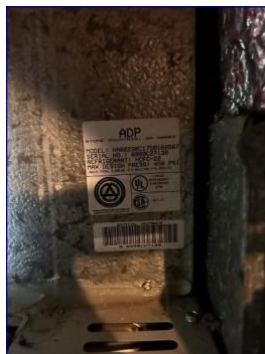
| Roof | | |
|---|---|---|
| Page 9 Item: 1 | Exterior A/C - Heat Pump 2 | • The air conditioner is nearing/past its expected life of 8-15 years. Recommend budgeting for replacement. |

- Model #PA10JA030000AGAA
- Serial #2005X54118
- The air conditioner is nearing/past its expected life of 8-15 years. Recommend budgeting for replacement.
- The air conditioner is nearing/past its expected life of 8-15 years. Recommend budgeting for replacement.

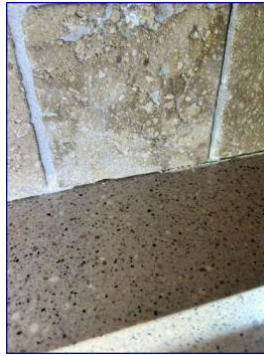
Condition:  
• Recommend repair/grout behind sink areas.  
Observations:  
• There are areas of missing or damaged grout in the kitchen. Recommend re grouting.

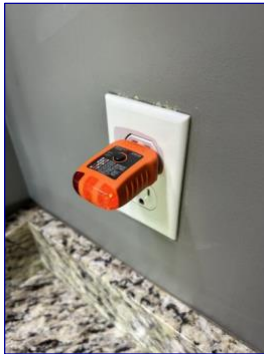
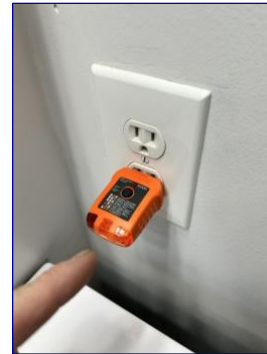
| Roof | | |
|---|---|---|
| Page 13 Item: 3 | Receptacles | • <b>GFCI</b> receptacles are not installed within six feet of water in all bathrooms, which is a safety concern. However, at the time the home was built, installing GFCI receptacles were not part of the standard building requirements. Recommend upgrading the GFCI receptacles to current standards for increased safety. |

- GFCI receptacles are not installed within six feet of water in all bathrooms, which is a safety concern. However, at the time the home was built, installing GFCI receptacles were not part of the standard building requirements. Recommend upgrading the GFCI receptacles to current standards for increased safety.
- GFCI receptacles are not installed within six feet of water in all bathrooms, which is a safety concern. However, at the time the home was built, installing GFCI receptacles were not part of the standard building requirements. Recommend upgrading the GFCI receptacles to current standards for increased safety.

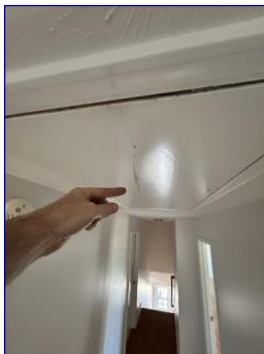
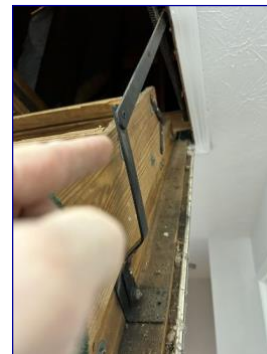
- Attic access pull down needs a new pull rope and spring arm. I recommend fixing or replacing by a licensed contractor.

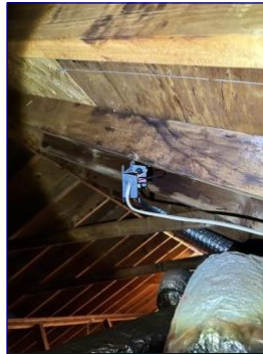
Open electrical box recommend fixing by a licensed electrical contractor

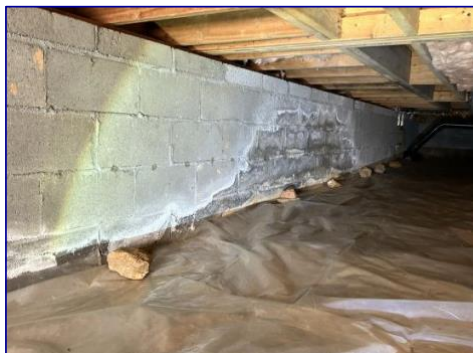
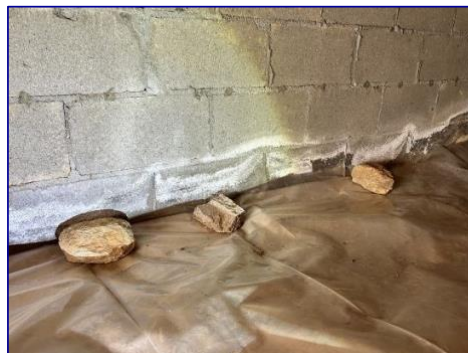
| Roof | | |
|---|---|---|
| Page 14 Item: 1 | Foundation Walls | • There is efflorescence on the foundation walls. Recommend monitoring and consulting a licensed contractor to repair as needed. |

- There is efflorescence on the foundation walls. Recommend monitoring and consulting a licensed contractor to repair as needed.
- There is efflorescence on the foundation walls. Recommend monitoring and consulting a licensed contractor to repair as needed.

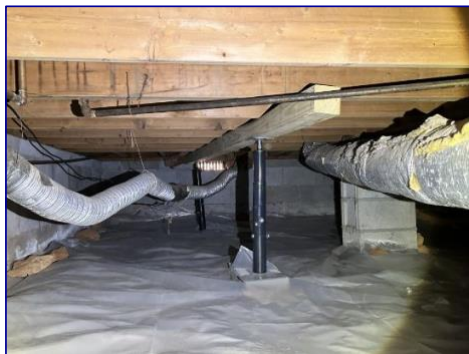
- The joists as seen in the crawl space have been supported with a beam and support jacks. Monitor as needed.

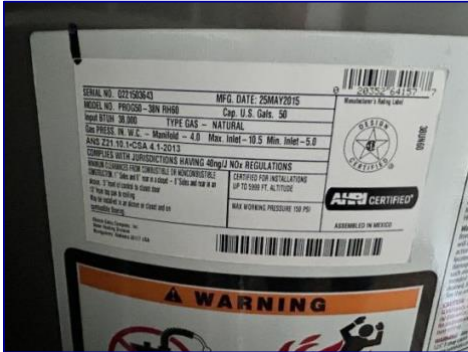
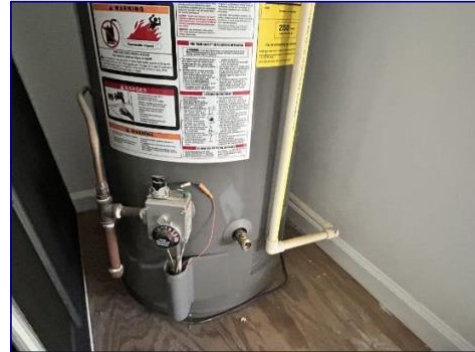
- The average life expectancy for a water heater is 8-12 years.
